ASD-TR-81-5016

INVESTIGATION OF SPATIAL DISORIENTATION OF F-15 EAGLE PILOTS

TECHNICAL REPORT ASD-TR-81-5016
Final Report 15 January 1980 - August 1980

DIRECTORATE OF EQUIPMENT ENGINEERING
AERONAUTICAL SYSTEMS DIVISION
AIR FORCE SYSTEMS COMMAND
WRIGHT-PATTERSON AIR FORCE BASE, OHIO 45433

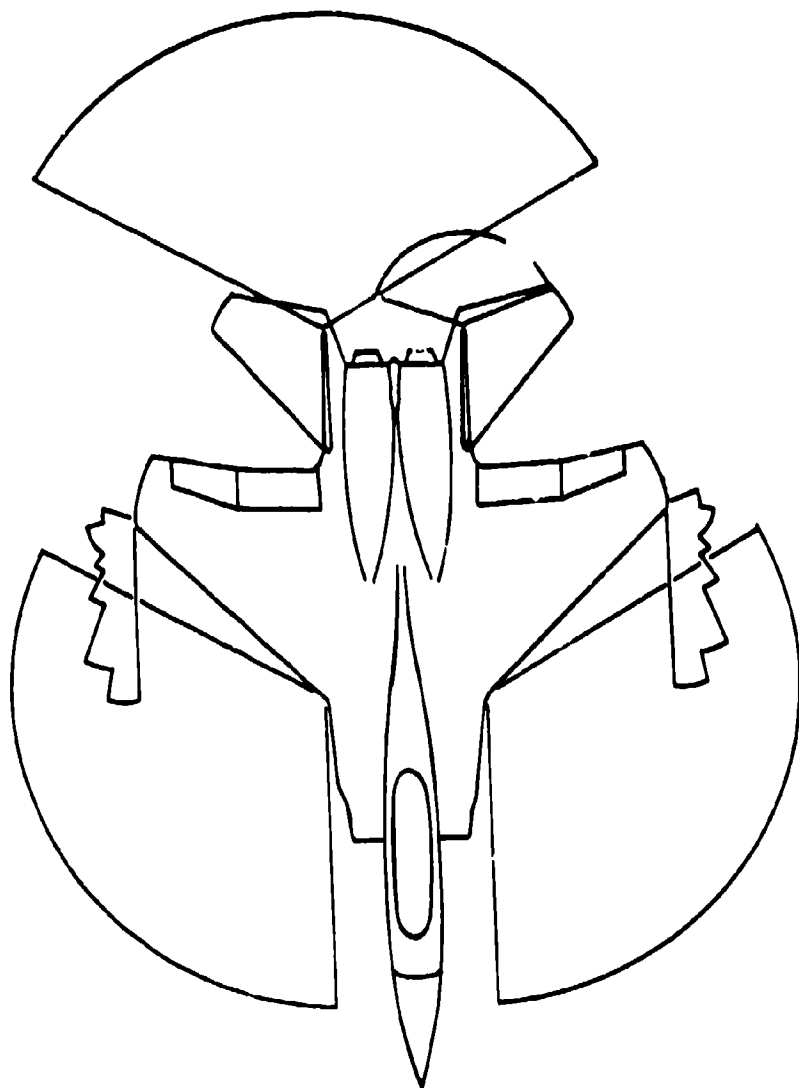
Figure 3

j. The lighting improvement included the addition to the wingtip position lights of a reflector for greater angular coverage and the combined addition of brighter bulbs. Also, brighter bulbs increased the angular coverage of the tail position light (See Figures 2 and 3).
